**Flood Control Project Maintenance  
Levee Inspections**  
**LMA District Cover Sheet**  
**Spring 2019 Levee Inspection Results**

**Sutter Maintenance Yard Maintenance Area 0016**

Waterway			Bank	Unit Miles
Unit No. 01 Feather River			Right	4.06
	Spring (March - May)	Summer (June - August)	(September - November) Fall	Winter (December - February)
Unit Maintenance Rating (Fall Only)				
Date of Inspection	4/4/2019 - 4/4/2019			
DWR Inspector	Sterling York			
Accompanied By	Shawn Freitag Sutter Maintenance Yard

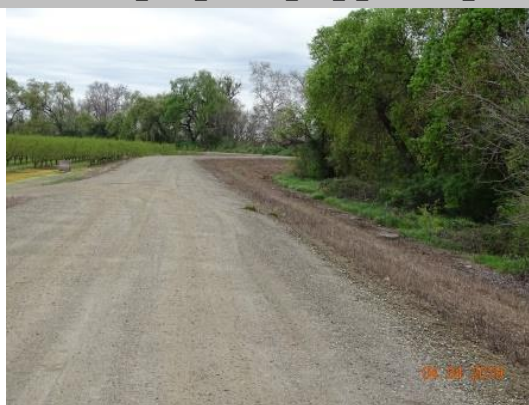
Photo 1 of 1 : SP\_2019\_MA0016\_302\_8\_20190409\_00012.jpg

LM Start	0.01	Rating **	A	Issue No.	8
LM End	4.06	Issue Type +	Ma	Location *	WS
Category	Earthen Levee			GPS Latitude/Longitude	
				Start	End
Item	Vegetation			39.255931 °	39.310941 °
				-121.636394 °	-121.637634 °
DWR ID	DWR_MA0016_01_s_2019_8				
Comment Code					
V1 : Control annual grass and weeds on the levee slopes and easements.					
Inspector Comment					
The annual vegetation is well maintained, Spring 2019.

View looking upstream waterside at the well maintained vegetation, Spring 2019.

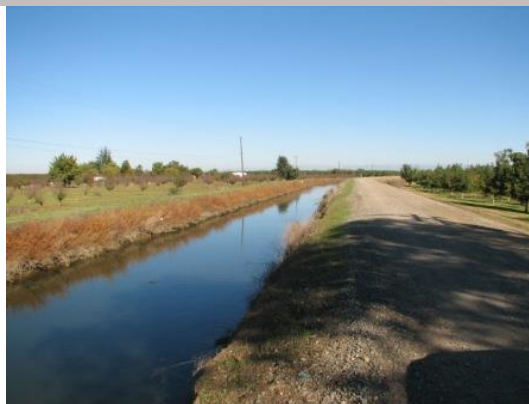
Photo 1 of 2 : SP\_2019\_MA0016\_302\_14\_20190305\_00001.jpg

LM Start	2.85	Rating **	M	Issue No.	14
LM End	3.08	Issue Type +	En	Location *	LS
Category	Earthen Levee			GPS Latitude/Longitude	
				Start	End
Item	Encroachments			39.293675 °	39.296748 °
				-121.636615 °	-121.638192 °
DWR ID	DWR_MA0016_01_s_2012_14				
Comment Code					
DT : Ditch					
Inspector Comment					
An agricultural ditch is located at the landside slope and toe.

View of agricultural ditch at the landside slope and toe.

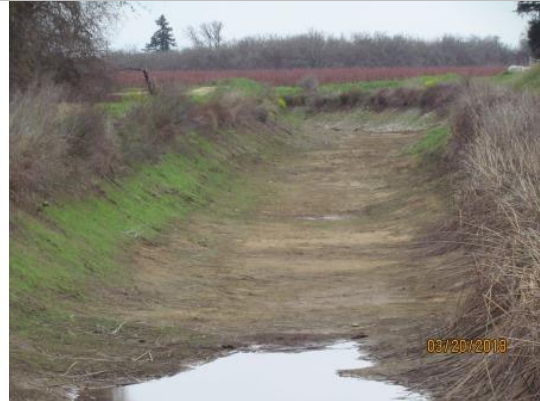
Photo 2 of 2 : SP\_2019\_MA0016\_302\_14\_20190305\_00002.jpg

LM Start	2.85	Rating **	M	Issue No.	14 (cont)	
LM End	3.08	Issue Type +	En	Location *	LS	
Category	Earthen Levee			GPS Latitude/Longitude		
				Start	End	
Item	Encroachments			39.293675 °	39.296748 °	
				-121.636615 °	-121.638192 °	
DWR ID	DWR_MA0016_01_s_2012_14					
Comment Code						
DT : Ditch						
Inspector Comment						
An agricultural ditch is located at the landside slope and toe.

View of agricultural ditch.

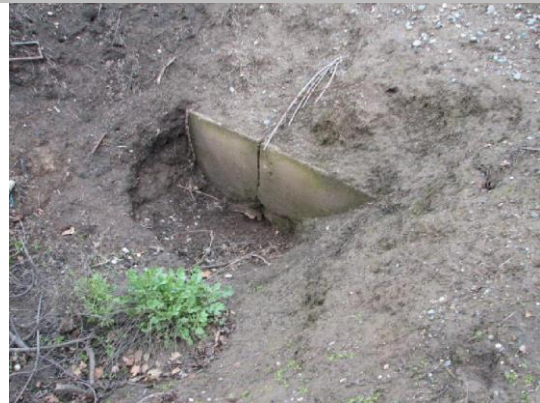
Photo 1 of 2 : UCIP\_SP\_2019\_54027\_65782.jpg

Comment Code						
Inspector Comment						
FS_ID:54027 DS_ID:17125 EP_NO: N/A Repair Type: Non-Urgent Crossing Status: Found UCIP Comments: 05/22/2019 (O. Magana - DWR UCIP)05/22/2017 LS inlet buried. WS access being blocked off by over grown vegetation. Pipe has been selected for internal cleaning and inspection as part of the DMP project. (DWR Sutter Yard - A Freitag)12/01/2016 LS inlet completely buried. (DWR Sutter Yard- A Freitag)05/26/2016 LS inlet was completely buried.06/08/2015 Concrete headwall is still cracked and inlet is buried. It was said to be replaced with the SBFCA project but the project skipped over in this area.12/29/2014 Same as last inspection.05/19/2014 Same as last inspection.11/06/2013 Same as last inspection.05/14/2013 SBFCA project recommends replacing in accordance with title 23. Same as last inspection.12/11/2012 Concrete headwall on LS toe is cracked through middle and pipe is burried in soil. pipe appears corroded. (DWR UCIP - W. Wylie) FIELD_STRUCT_DESC: 1 of 2: 24-inch corrugated metal drainage pipe through the levee, 16.6 feet below the crown. Concrete headwalls on both the waterside (WS) and the landside (LS) ends. Flap gate on the WS end. [Additional Reference(s): DWR Levee Log, 2005. USACE Sacramento O&M Manual 148, August 1955, (Station 646+96)]. FS Date: 5/22/2019 3:47:39 PM

Headwall at LS toe is cracked and the inlet is buried in soil.

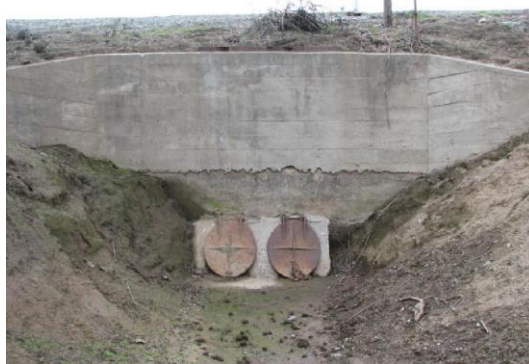
Photo 2 of 2 : UCIP\_SP\_2019\_54027\_65781.jpg

Comment Code						
Inspector Comment						
FS_ID:54027						
DS_ID:17125						
EP_NO: N/A						
Repair Type: Non-Urgent						
Crossing Status: Found						
UCIP Comments: 05/22/2019 (O. Magana - DWR UCIP)05/22/2017						
LS inlet buried. WS access being blocked off by over grown						
vegetation. Pipe has been selected for internal cleaning and inspection						
as part of the DMP project. (DWR Sutter Yard - A Freitag)12/01/2016						
LS inlet completely buried. (DWR Sutter Yard- A Freitag)05/26/2016						
LS inlet was completely buried.06/08/2015 Concrete headwall is still						
cracked and inlet is buried. It was said to be replaced with the SBFCA						
project but the project skipped over in this area.12/29/2014 Same as						
last inspection.05/19/2014 Same as last inspection.11/06/2013						
Same as last inspection.05/14/2013 SBFCA project recommends						
replacing in accordance with title 23. Same as last

inspection.12/11/2012 Concrete headwall on LS toe is cracked						
through middle and pipe is burried in soil. pipe appears corroded.						
(DWR UCIP - W. Wylie)						
FIELD_STRUCT_DESC: 1 of 2: 24-inch corrugated metal drainage pipe						
through the levee, 16.6 feet below the crown. Concrete headwalls on						
both the waterside (WS) and the landside (LS) ends. Flap gate on the						
WS end. [Additional Reference(s): DWR Levee Log, 2005. USACE						
Sacramento O&M Manual 148, August 1955, (Station 646+96)].						
FS Date: 5/22/2019 3:47:39 PM

Headwall on WS toe with flap gates.

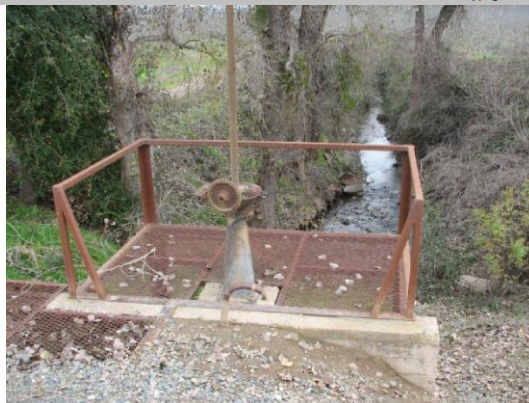
Photo 1 of 3 : UCIP\_SP\_2019\_54030\_65785.jpg

FS\_ID:54030  
DS\_ID:17123  
EP\_NO: N/A  
Repair Type: No Action Needed  
Crossing Status: Found  
UCIP Comments: 05/22/2019 (O. Magana - DWR UCIP)05/22/2017 Crossing appears to be in good condition. (DWR Sutter Yard - AFreitag)12/01/2016 Crossing appears to be in good condition. (DWR Sutter Yard- AFreitag)05/26/2016 Crossing appears to be in good condition.06/08/2015 Pipe appears to be in good condition. No noticeable issues to report. Pipe was listed to be replaced with the SBFCA project but the project did not take place in this area.12/29/2014 Same as last inspection.05/19/2014 Same as last inspection.11/06/2013 Same as last inspection.05/14/2013 Slide gate opened allowing water to flow through, debris problem has been cleared and the gates seem to be functioning properly. SBFCA project recommends replacing in accordance with title 23.12/11/2012 Lock missing from concrete well access door-this should be resplaced. Some debris blocking preventing flapgate from completely closing. (DWR UCIP - W. Wylie)

Slide gate, concrete well, siphon breaker/air vent and open channel on WS of levee.

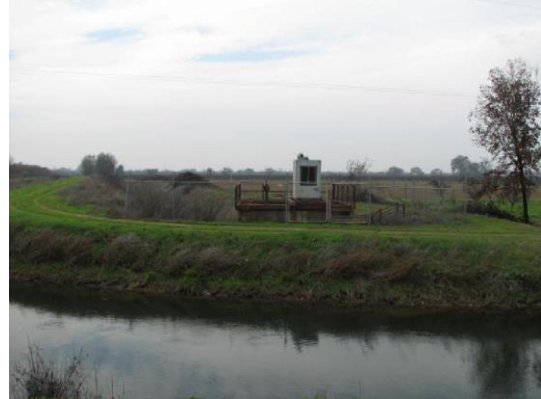
Photo 2 of 3 : UCIP\_SP\_2019\_54030\_65784.jpg

Pumping plant and slide gate on LS accross canal. (no access from levee).

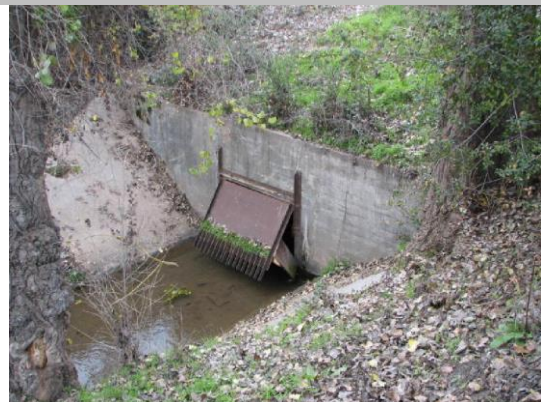
Photo 3 of 3 : UCIP\_SP\_2019\_54030\_65783.jpg

Concrete headwall and flap gate on WS toe.
